# Inventory & Check In

020 3322 6662

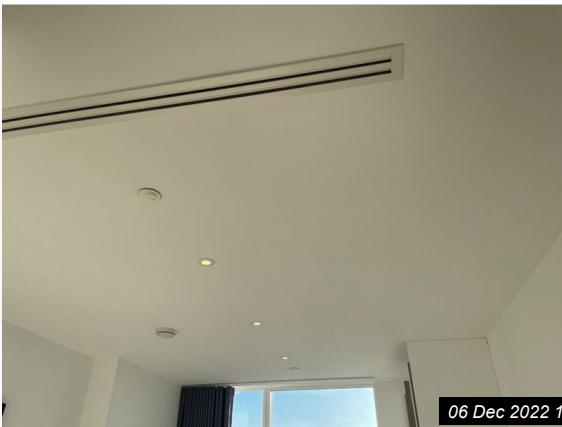
| 8.14 | Heating | 1 x white metal radiator | <p>In order</p> <p>Not tested</p> | |

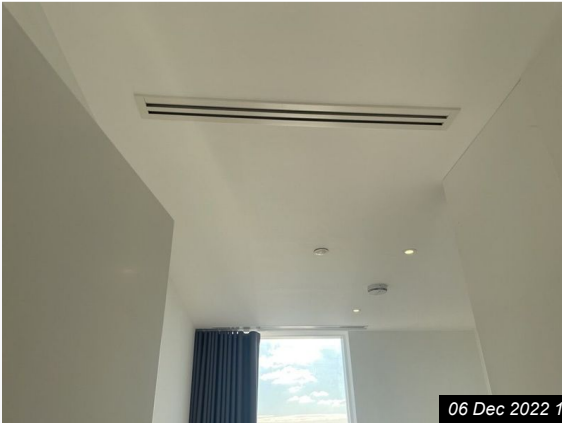
| 11.15 | Contents | 2 grey scatter cushions | In good condition | |

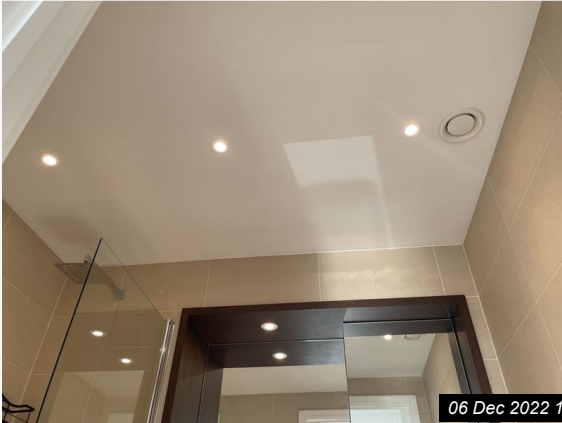
12. BATHROOM (CONT.)
